**GENERATOR GAP3 & TWO COIL REWIND AND ROTOR BORE LEAD OUT
CONDUCTOR REPLACEMENT**

**ANNUAL OVERHAUL 2021 CONTRACTOR WORK SCOPE
BOGUE POWER STATION**

GENERATOR INSPECTION REPORT

Brushless Exciter Inspection and Repair

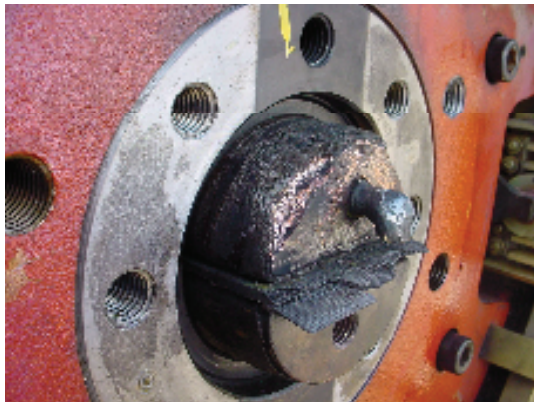
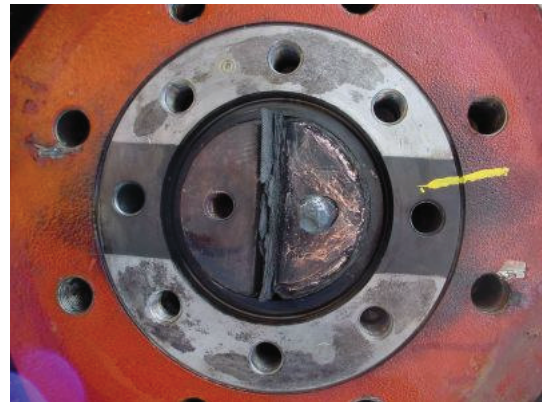
The bore copper is the component that took most of the damage. The insulation between the bore copper was totally burned at that area. The insulation around both bars of the bore copper was damaged too. It can be noticed on image 3 and 4 the bore copper that took most of the damage as it still had a melted bolt into the bore copper. The insulation of the bore copper was carbonized due to the extreme heat on that area.

1- The insulation between the bore copper. The burned insulation was partially removed using a file and sand paper. A piece of G11 was cut and reduced to a size were it could introduced between the bore copper. Then it was glued with Barco Bond in place. The area where the copper was removed due to the high temperatures during the incident was filled with Barco Bond too.

2- The insulation around the bore copper was protected with Nomex 5 mills thick. The Nomex was glued with Barco Bond to the bore copper insulation and then pressed together with varnished glass tape.

THIS PATCH TO THE BORE COPPER CANNOT BE CONSIDERED AS PERMANENT. THIS FIX WILL ALLOW TO OPERATE THE UNIT WHILE JPS CAN PROGRAM AND OUTAGE AND REPLACE THE BORE COPPER IN A ROTOR PARTIAL REWIND. THIS SHOULD BE DONE NO LATER THAN SIX MONTHS FROM THE COMPLETION OF THIS OUTAGE.

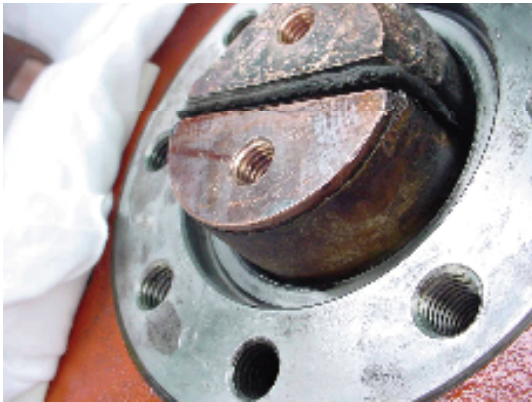
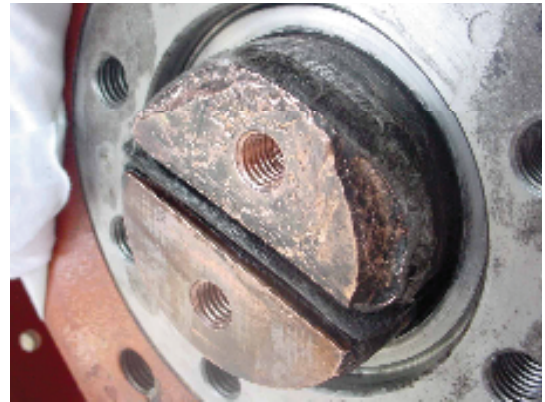
Images 5 and 6 show the cleaned bore copper area after the burnout and image 10 show the bore copper with the patch fix.

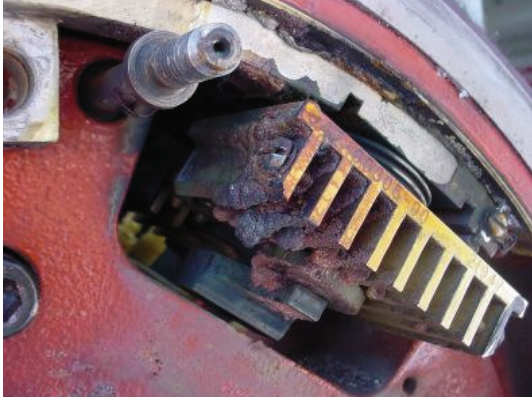
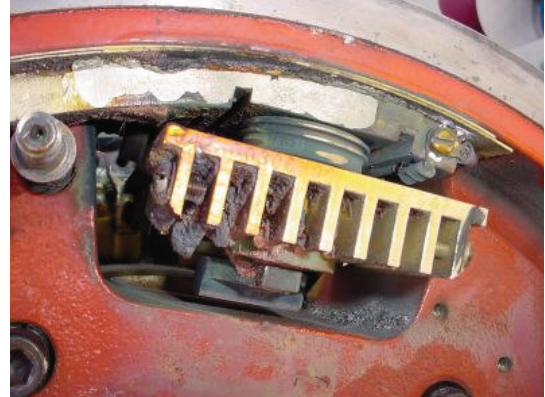
This unit was forced out of service due to a failure of the rotating excitation system. Apparently one of the main leads got loose and it caused a permanent ground that melt of main leads connectors. The diode wheel assembly was severely damaged, one of the diodes and heat sink were damaged too. After removing the diode wheel assembly the diode wheel forging was found damaged at the same location where the diode failed.

Images 7 and 8 show the original condition of the diodes and the heat sink after the unit's failure.

Image 8 show the original condition of the diode wheel assembly after the unit's failure.

All components were removed from the diode wheel assembly except the diode wheel forging. New diodes, heat sinks and bolts were installed and it was verified their correct operation. The original diode failure monitor and field ground monitor transmitters were cleaned, revised and installed back on the diode wheel assembly.

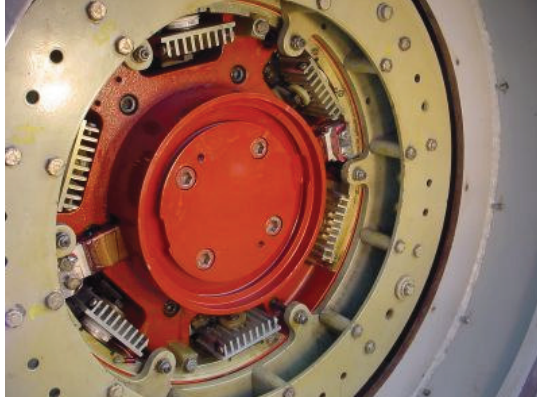
Image #11

Image 11 show the condition of the diode wheel assembly after all components were installed on the rotor.

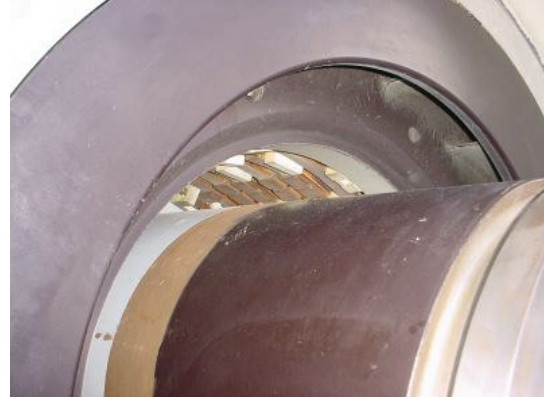
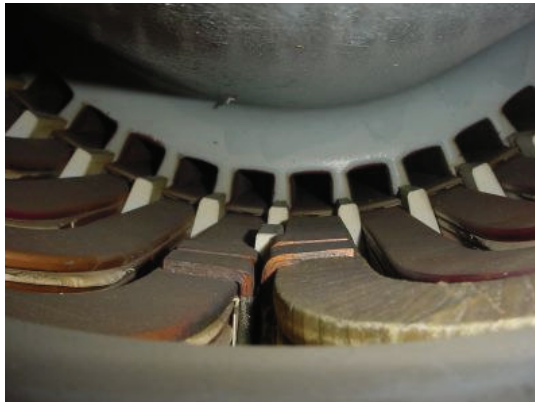
Images 12, 13 and show a good visual condition of the rotor winding under the retaining ring, the slots ventilation paths and the main terminal stud to the rotor windings.

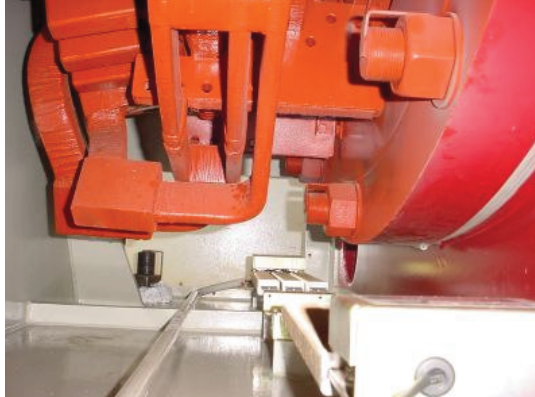
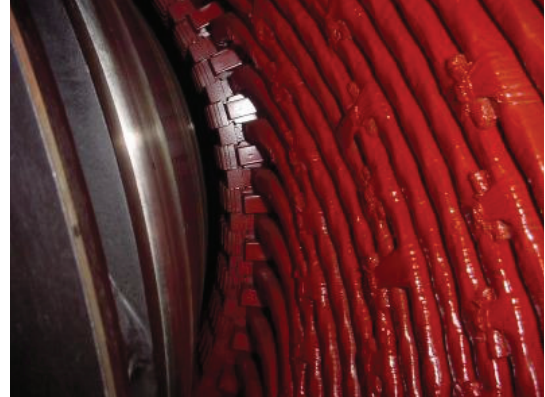
Visual Inspection on the end windings on both ends of the generator was performed. The generator end windings are clean and the overall condition is good. No components were found defective and all blocking was in good condition.

Images 15 and 16 show the typical condition of this generator's end windings.
